Pubblicate le prime risultanze del Marine Accident Investigation Branch sul naufragio del Bayesian

Interim report on the investigation into the foundering of the yacht *Bayesian*, with the loss of seven lives, 0.5 nautical miles south-east of Porticello, Italy on 19 August 2024

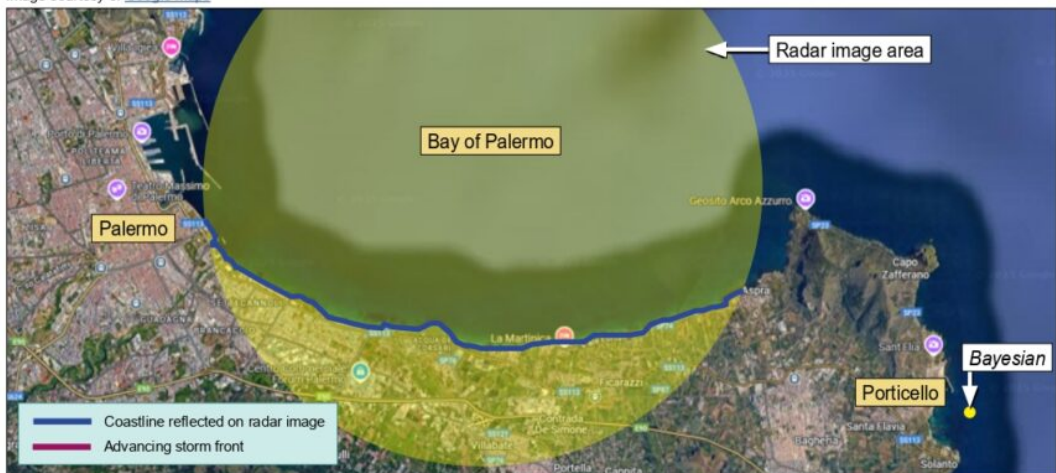
Figure 3: Radar images, showing passage of rain across the Bay of Palermo on 19 August 2024

At 0352 on 19 August 2024, around 5nm to the north-west of the Porticello anchorage, winds were recorded to have suddenly increased from around 5kts to 41kts from the north-west. These strong winds were associated with a storm front that passed quickly towards the rugged coastline near Bagheria and Porticello. This was observed on a nearby vessel's navigational radar (**Figure 3**). Several CCTV cameras in Porticello showed an intense squall of wind and heavy rain arriving, throwing debris around violently before moving on. This intense squall was associated with lightning strikes, thunder and very poor visibility. Land weather readings (recorded at 5-minute or hourly intervals) captured a peaking of wind strength as the intense squall passed.

The Met Office study of satellite imagery indicated that the mesocyclonic storm front was demonstrating the properties of a significant supercell with associated downdrafts and possible near-surface winds in excess of 100 miles per hour (87kts). The study concluded that a mesocyclonic storm was *highly likely* with
